MEMORANDUM

Prepared for: Marianne Bishop, San Ignacio Homeowner's Association

Prepared by: Kara D. Festa, P.E., WestLand Resources, Inc.

RE: **EROSION AND SEDIMENT CONTROL
WESTLAND PROJECT NO. 1766.01**

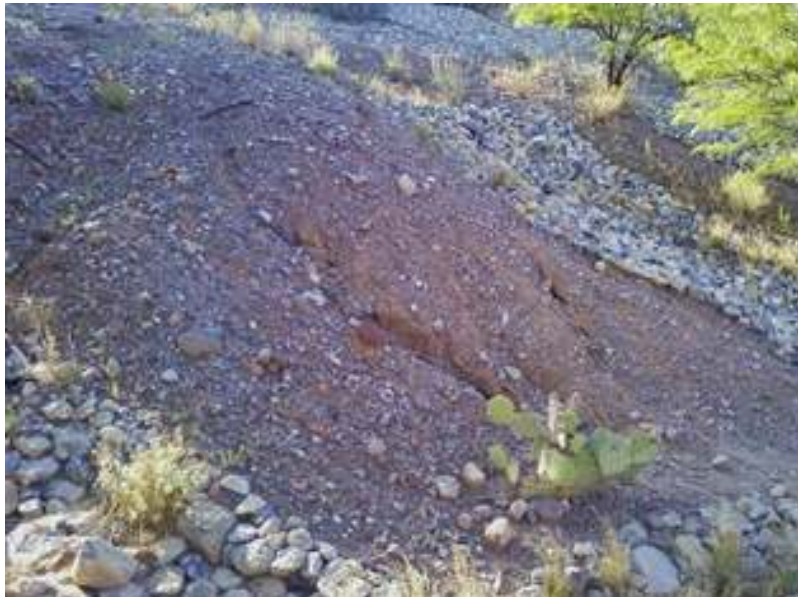
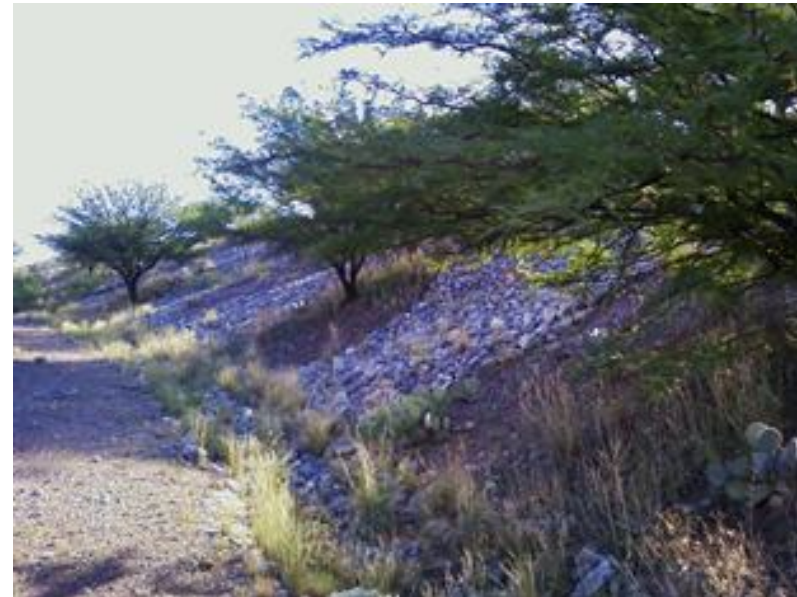
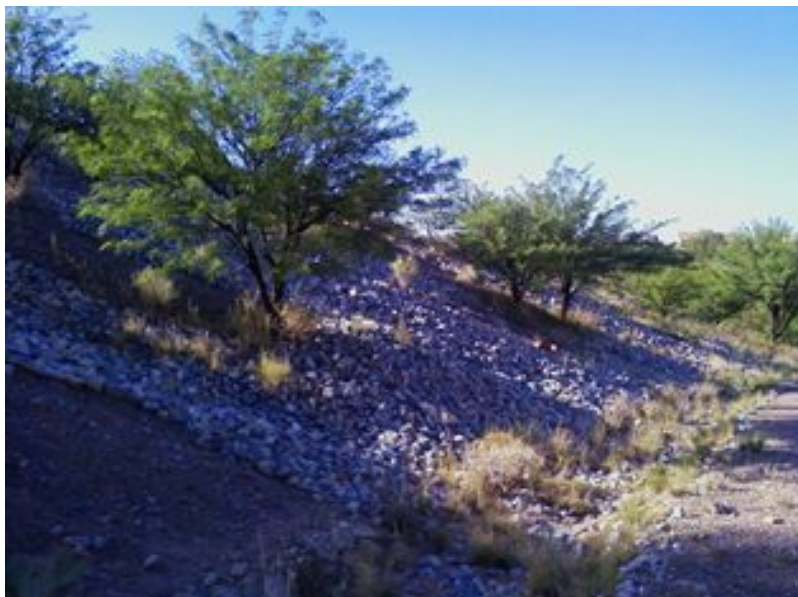
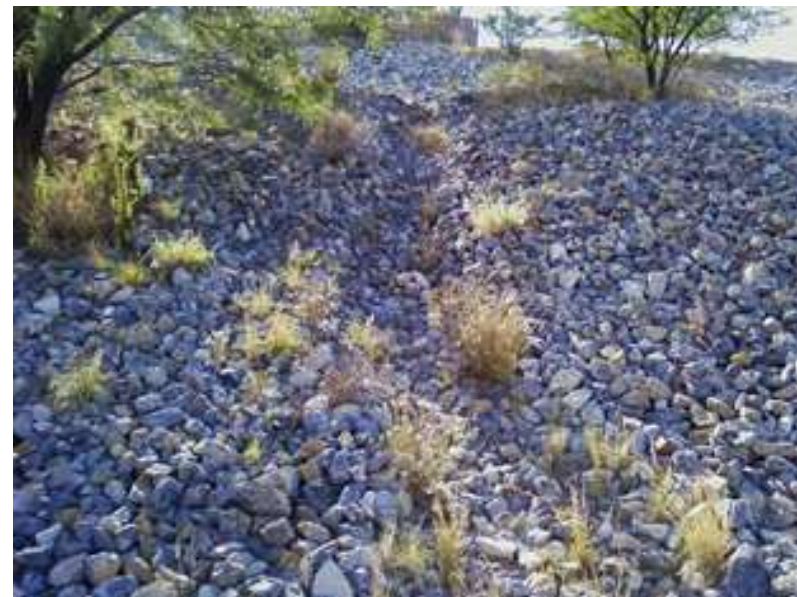
As depicted in (Photos No.1 through 4), it is noted that drainage rivulets are occurring between the existing riprap areas that have no vegetative cover. Compounding this problem is drainage that runs downhill to the west from an existing bench/swale that occurs roughly halfway up the slope (Photos No 5 and 6). This drainage appears to be intended to travel southerly along the bench/swale to reach the existing retention basin/drainage structures located at the northern corner of Calle Tres and Camino Del Sol (Photo No. 7).

Photo 1. Area 1 – Bottom slope adjacent to Camino Del Sol looking east.

Photo 2. Area 1 – Bottom slope adjacent to Camino Del Sol looking north.

Photo 3. Area 1 – Bottom slope adjacent to Camino Del Sol looking south.

Photo 4. Area 1 – Bottom slope adjacent to Camino Del Sol looking east towards the back corner of Lot 10.

The rivulets in this area are a common occurrence throughout Southern Arizona due to the soil characteristics, especially in areas with steep unvegetated slopes. There are some locations where extending the filter fabric and riprap will aid in the protection and stabilization of the slope, and other areas where we suggest filling/scarifying the slopes and applying an approved native seed mix.

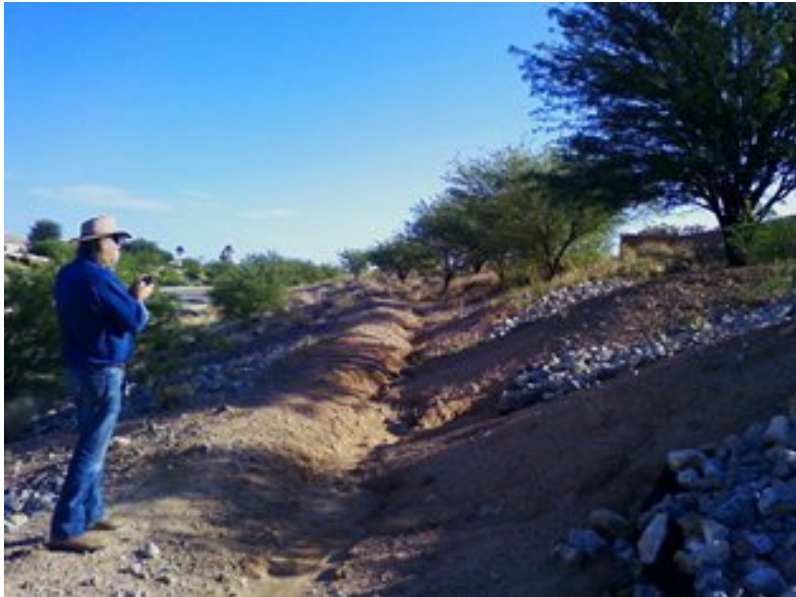
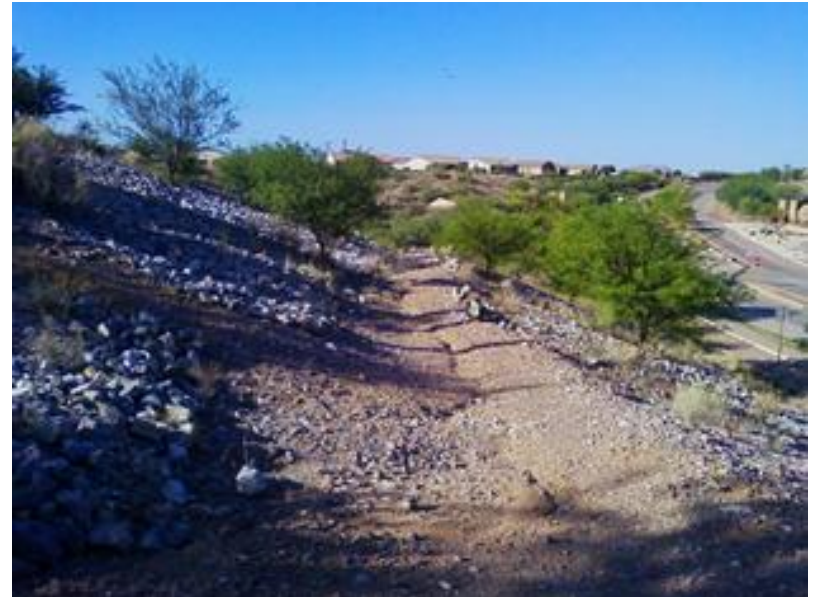
Photo 5. Area 1- Mid-slope bench/swale looking north.

Photo 6. Area 1 – Mid-slope bench/swale looking south.

In addition, we suggest that minor grading occur along the bench/swale locations to ensure positive drainage towards the south and into the existing retention basin area.

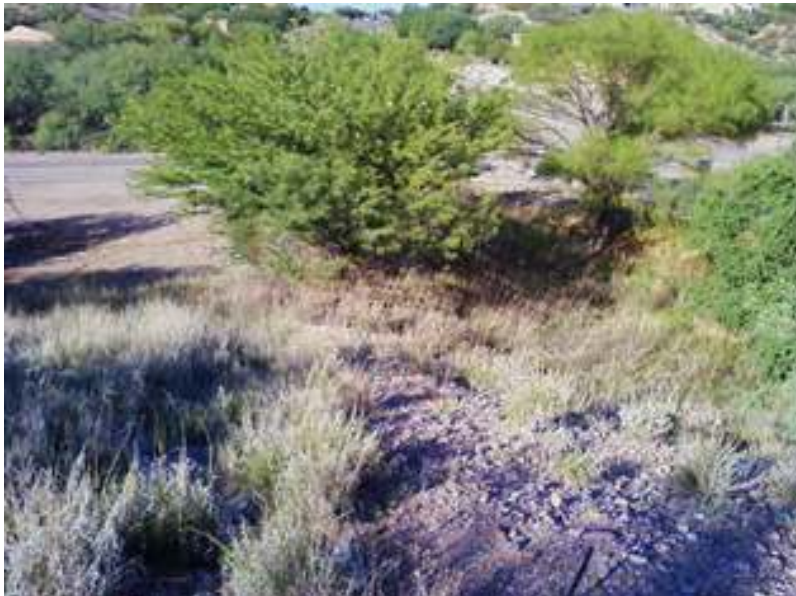
Photo 7. Area 1 – Mid-slope bench/swale looking south towards retention basin/drainage structures.

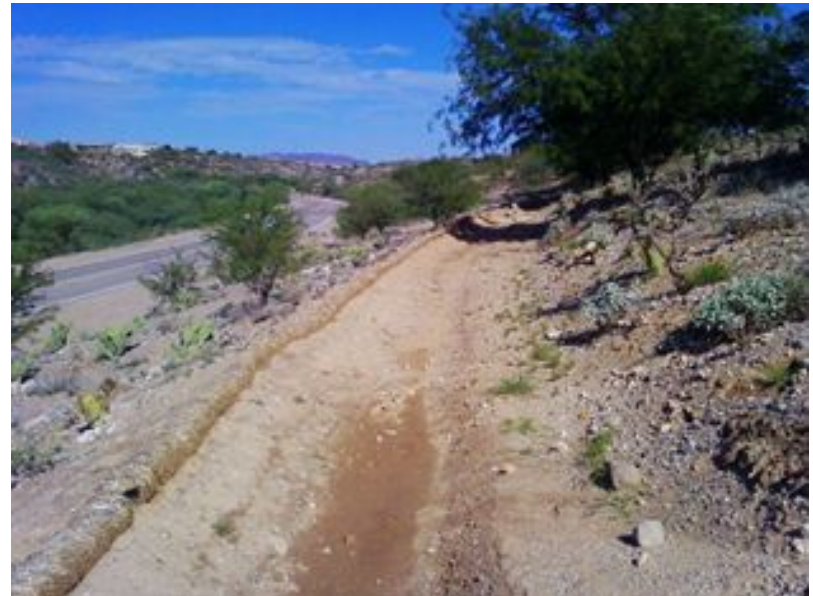
Area 2 is located along the back of the lots north of Calle Tres and east of View Ridge Drive (*Figure 1*). This area is currently utilizing a bench/swale with straw waddles (Photo No. 8) located approximately halfway up the slope from Calle Tres toward the back of the lots. This treatment appears to be functioning and no rivulets of any significance were noted downhill from Area 2.

Photo 8. Area 2 – Mid-slope bench/swale with straw waddles looking west.

Inspection of these areas should occur no less than annually and also following significant rainfall events to ensure that the bench/swale and straw waddles are still functioning properly and that no additional erosion is occurring behind Lot 138.

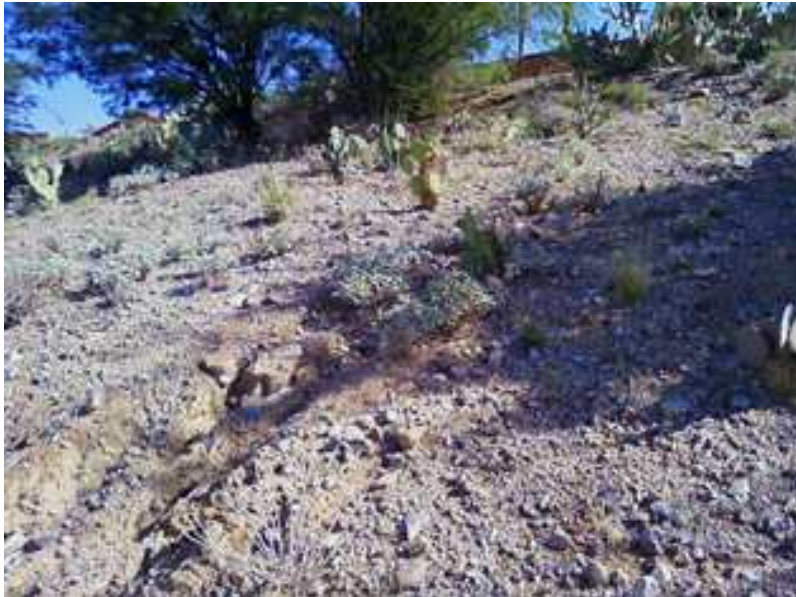
There are some minor rivulets occurring north of this bench/swale (Photo No. 9) and some erosion occurring near the rear of Lot 138.

Photo 9. Area 2 – From mid-slope bench/swale looking north.

These locations appear to be treatable by placing riprap in the area behind Lot 138, exercising caution not to disturb or remove any of the existing trees or vegetation, and by performing some minor regrading in the areas of the rivulets and applying an approved native seed mix.

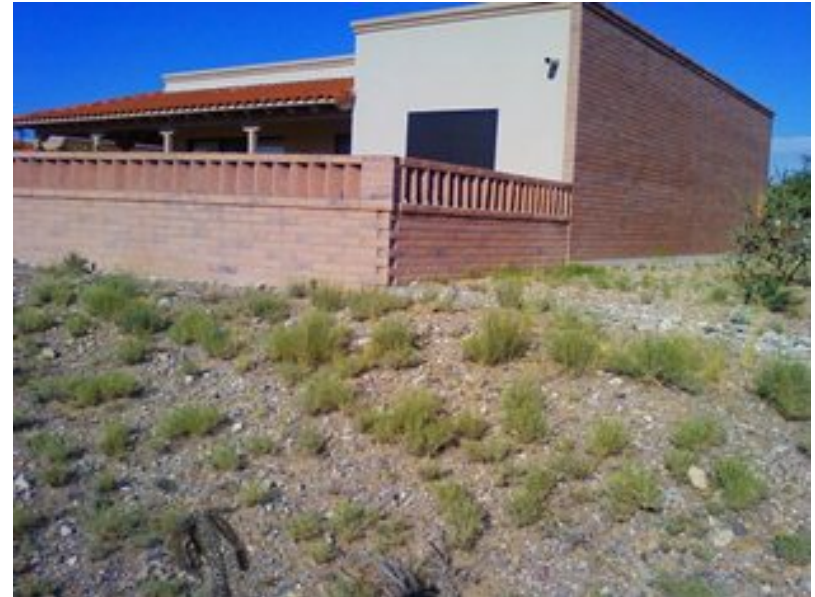
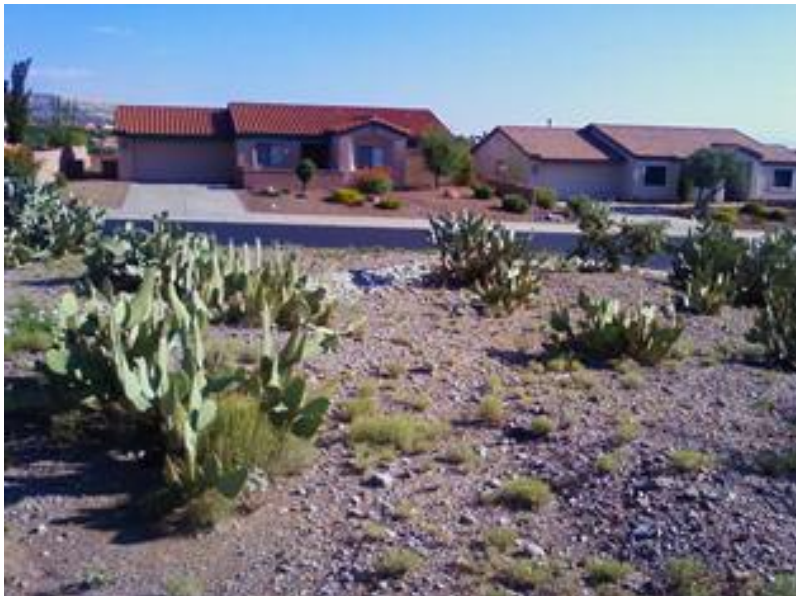
Area 3 is located at the southwest corner of Gloria Vista Drive and Vista Ridge Drive (*Figure 1*). This location has an existing functioning riprap swale that runs from the corner of Lot 206 to the handicap access ramp at the southeast corner of Gloria Vista Drive and Vista Ridge Drive (Photos No. 10 and 11).

Photo 10. Area 3 – Looking west towards corner of Lot 206.

Photo11. Area 3 – From common area east of Lot 206 looking north.

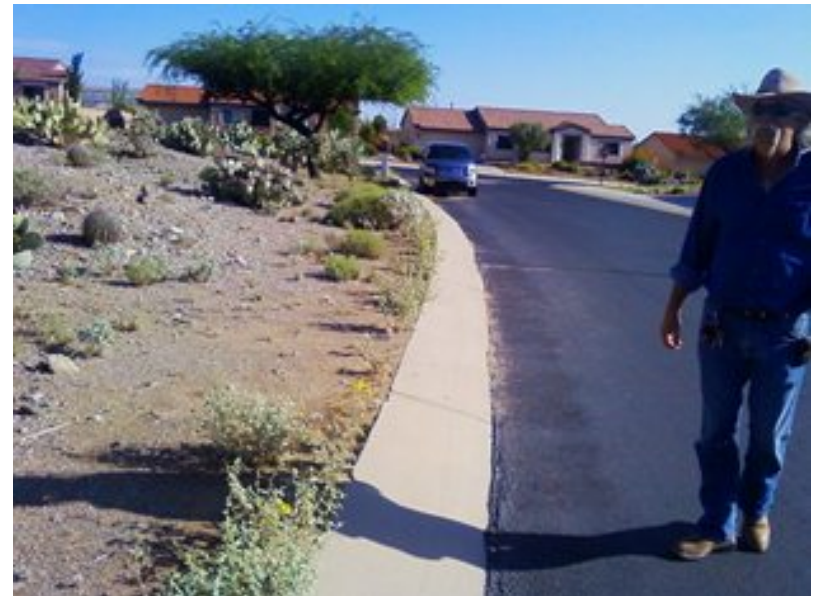
Nuisance drainage from the earthen/landscaped common area between the back of lots and the street is not making its way to the existing swale and is overtopping the existing concrete curb depositing sediment along the roadway (Photo No. 12).

Photo 12. Area 3 – West edge of Gloria Vista Drive looking north towards Vista Ridge Drive.

It is recommended that an approximate 2-foot wide riprap swale be constructed in the common area to direct and carry this flow into the existing riprap lined channel. In addition, in areas where sediment is overtopping the back of curbs, we suggest removing a 2-foot wide swath of dirt, approximately 8-inches deep and placing riprap in this area, directly behind and even with the top of the existing back of the curbs. This will allow sediment to be captured within the rock and allow drainage to follow the intended pattern.

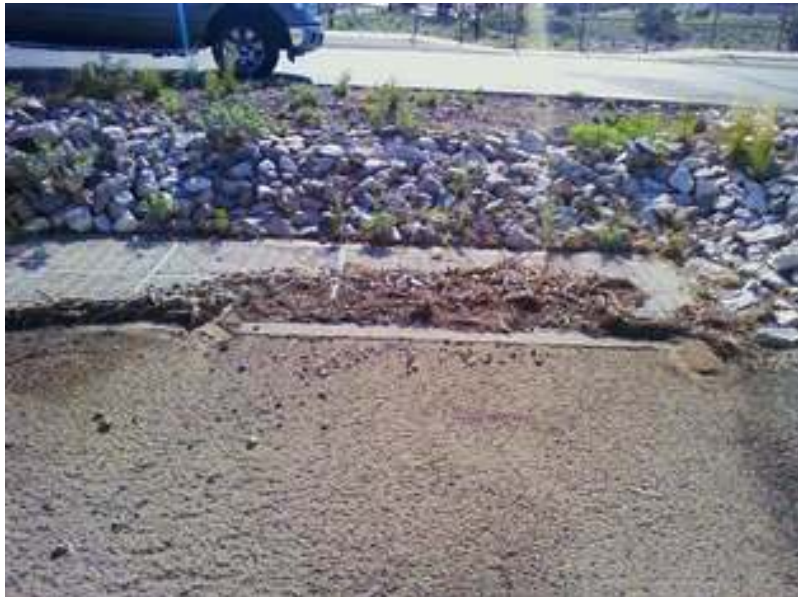
Area 4 is the common area located southwest of the bend of Vista Ridge Drive, west of the intersection with Hidden Crest Court (*Figure 1*). Part of this area's drainage scheme begins at an area drain inlet located at the southwest corner of Vista Ridge Drive and Harvest Moon Drive (Photo No. 13). At the time of the site visit this drain was partially clogged with sediment and debris from nearby vegetation. This drainage flows through piping to another area drain located west of the guest parking (Photo No. 14). From this point the drainage is carried east under View Ridge Drive to its release point in the common area between Lots 88 and 89. In addition some of the post barricades are loose due to erosion around the base and should be reset.

Photo 13. Area 4 – Drainage inlet at southwest corner of Vista Ridge and Harvest Moon Drive looking east.

The earthen/landscaped common areas feeding into this area drain also needs to have some minor grading to install for a 2 to 3-foot wide riprap swale behind the parking area to direct the drainage flow into the existing riprap collection area. The area of rip rap surrounding this area drain is full of sediment and should be cleaned out.

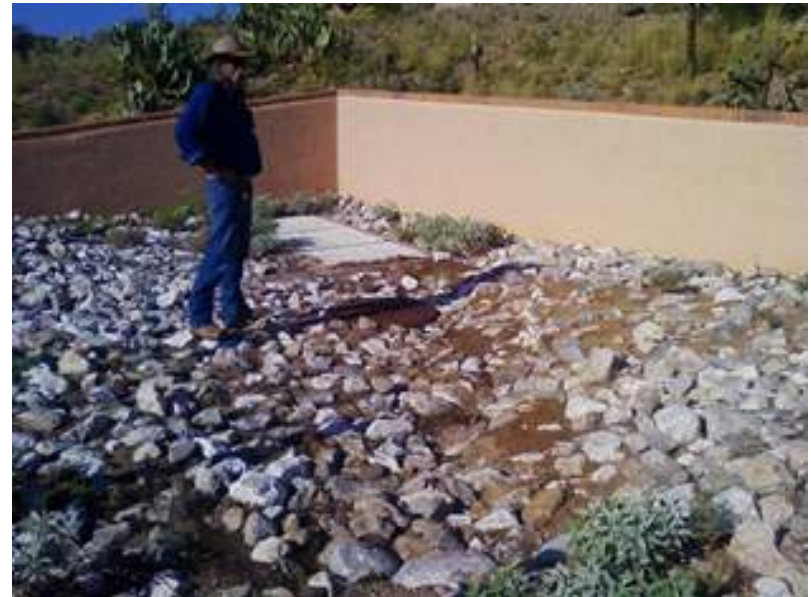
Photo 14. Area 4 – Riprap collection area and area drain – View Ridge Drive at Hidden Crest Court looking west.

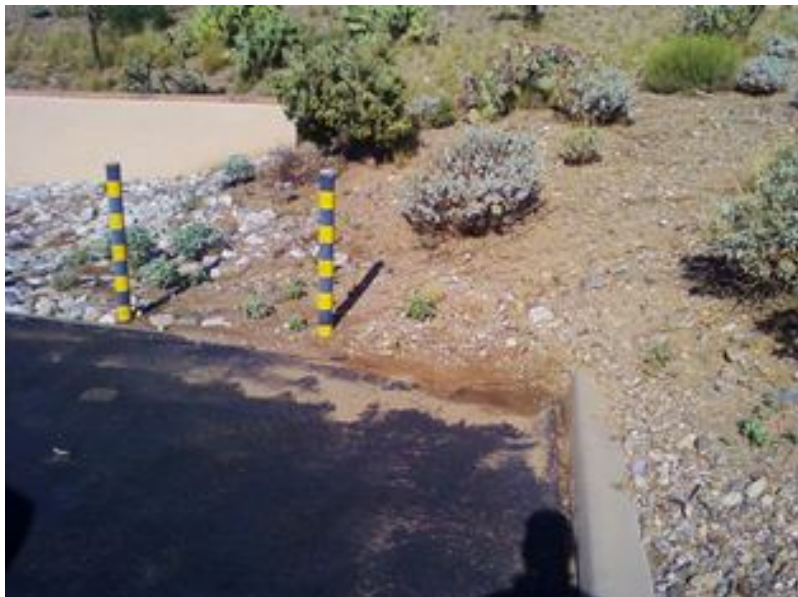
The drainage structures and piping appear to be functioning as intended. However, sediment from the swale west of View Ridge Drive is being deposited at the northwest corner of the paved guest parking area (Photo No. 15)

Photo 15. Area 4 – Common area, riprap collection area and guest parking. View Ridge Drive at Hidden Crest Court looking west.

Some grading needs to occur in this area to provide positive drainage towards the area drain away from the edge of the guest parking area. As an addition or alternate, a concrete curb could be added at this location from the existing curb termination to just past the second post barricade.

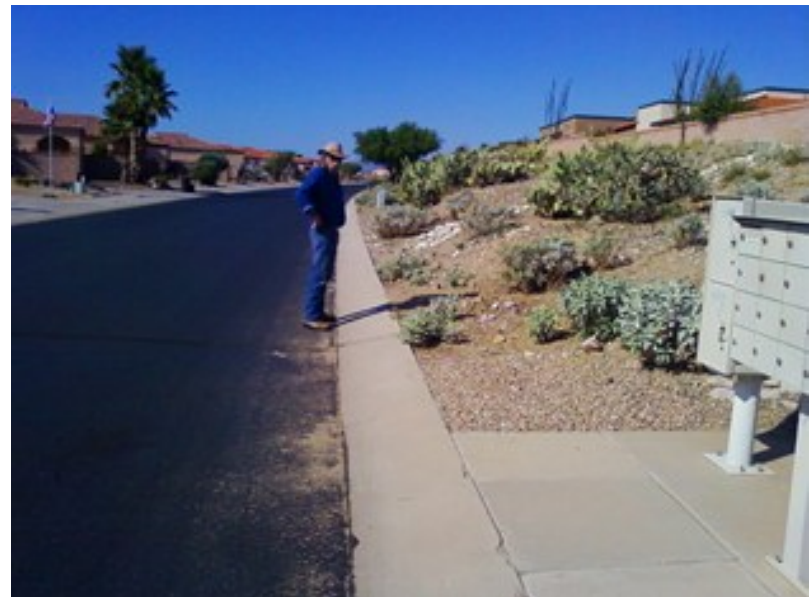
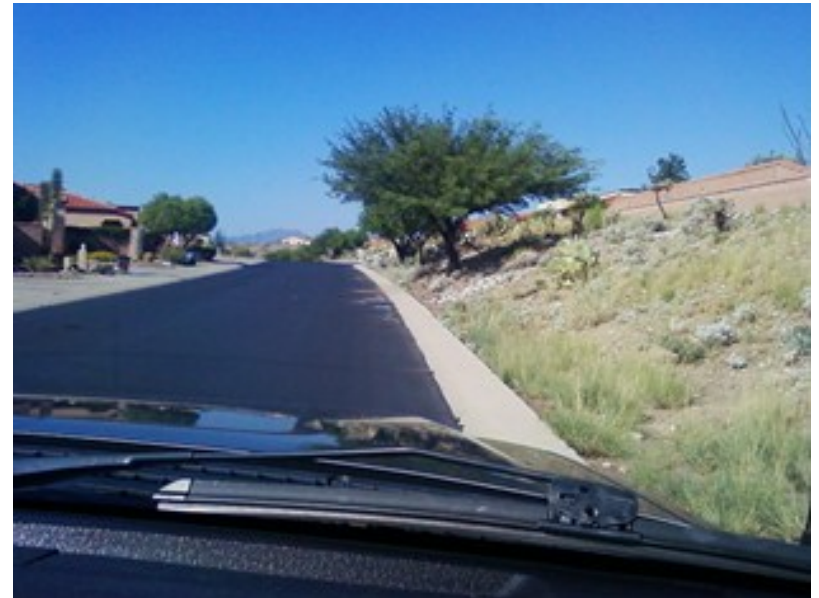
Area 5 is the common area located west of View Ridge Drive from Sonoran View Drive to the pedestal mailbox (*Figure 1*). Photos No. 16 through 18 were taken along the west side of View Ridge Drive from the pedestal mailbox towards Sonoran View Drive. The photos demonstrate that the flows run down the hill and past the existing curb and deposits sediment on the roadway. Photo No. 17 shows an area where over time the curb and roadway have sunk creating a low spot that holds water (birdbath).

Photo 16. Area 5 – View Ridge Drive looking south.

Photo 18. Area 5 – View Ridge Drive looking south.

In areas where sediment is running over the back of curbs, we suggest removing a 2-foot wide swath of dirt, approximately 8-inches deep and placing riprap in this area, directly behind and even with the top of the existing back of the curbs. This will allow sediment to be captured within the rock.

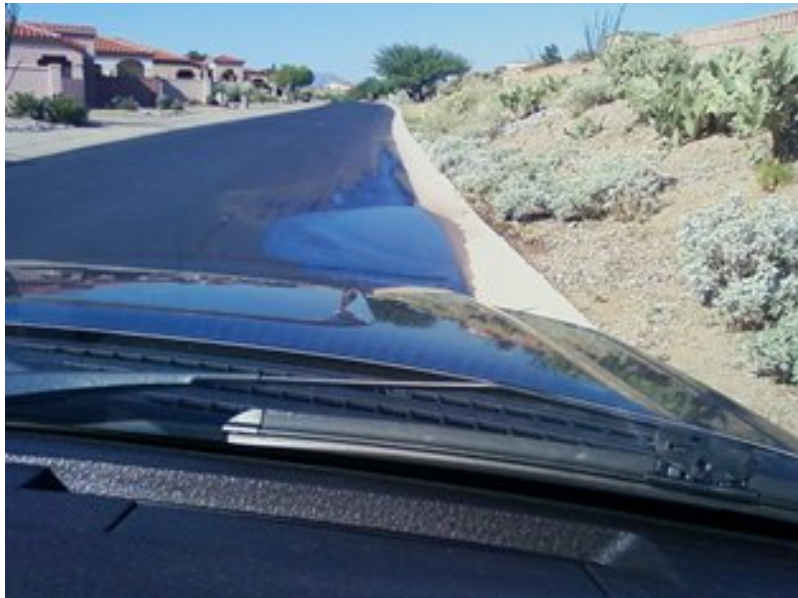
Photo 17. Area 5 – View Ridge Drive looking south (birdbath).

In the area of the birdbath, we suggest removing and replacing the asphalt and curb as this condition will only worsen with time due to the effect of standing water on pavement and underlying soil.
