MAINTENANCE PROJECT REPAIR- NOVEMBER 2010

STORM DAMAGE ALONG CALLE TRES

REPAIR PROJECT

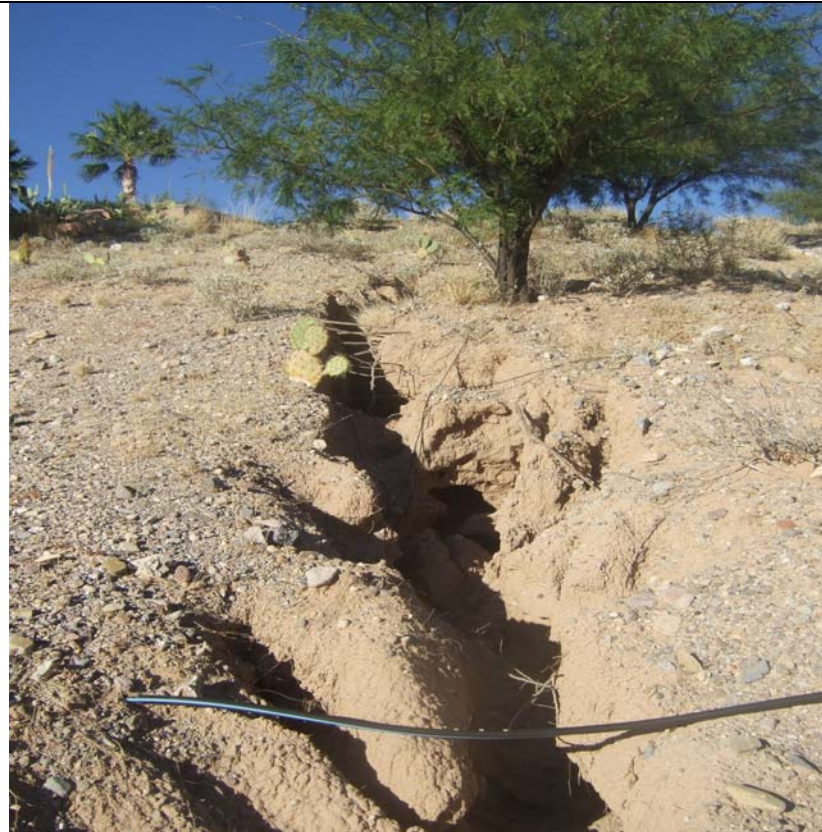
PICTURE TWO

This picture shows how water diverted from the normal drainage channel created a **deep crevice or fissure** that was, in places, nearly 5 feet deep. This threatened the integrity of the hillside.
