Final Report and Recommendations

Common Area Long Range Plan

San Ignacio Vistas, Inc. HOA

August 31, 2013

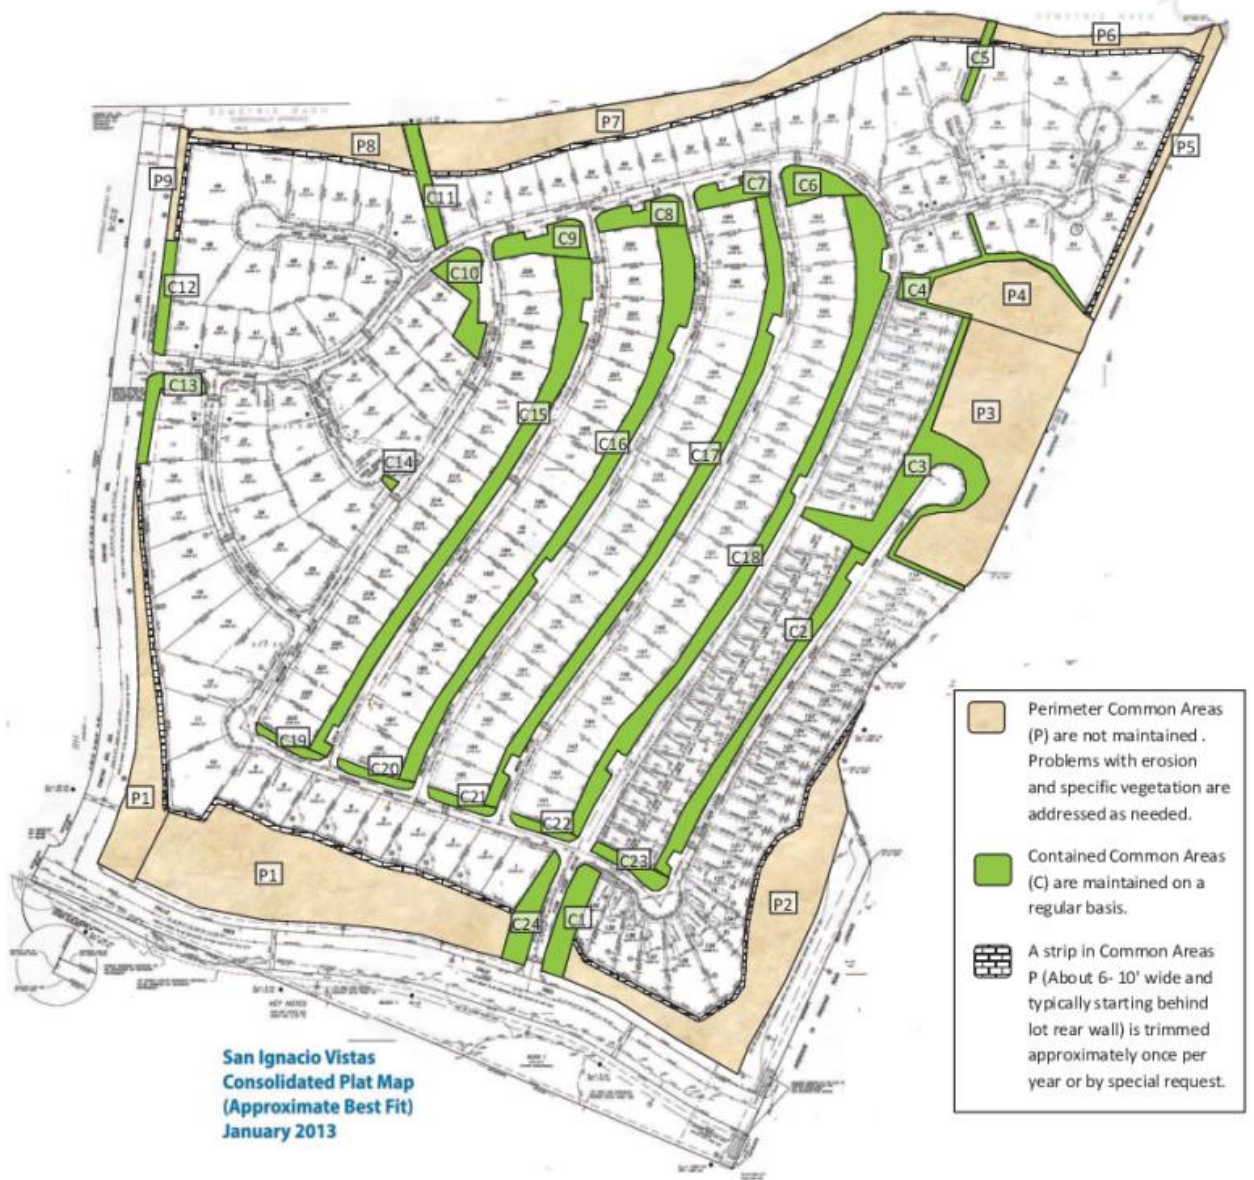
Designation Map:

Key to Common Area Designations on Map and Acreage Inventories:

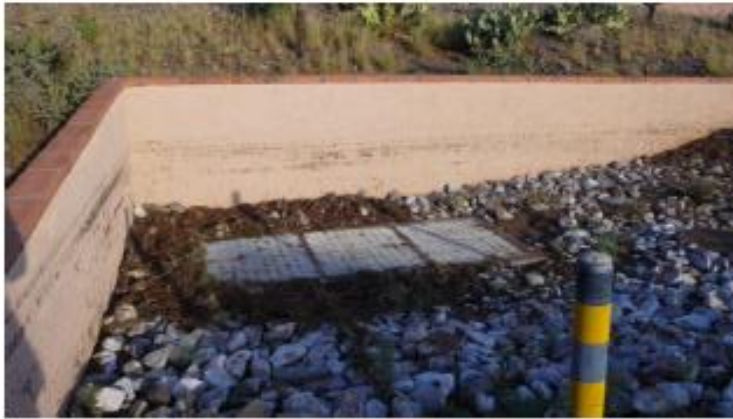
Flooding at View Ridge Storm Drain

1. Observed Cause
 - Water could not enter drain due to catch basin grates being clogged with debris.
2. Assumptions
 - If water can enter catch basin, it will drain without a problem.
 - During light rains, debris should be trapped by grates for later removal and to help prevent build-in catch basin.
 - During heavy rains, debris entering catch basin will be carried away.
 - Modifications should utilize the existing catch basin grate support structure.
3. Possible Action
 - Raise two grate sections approximately 12" to allow heavy rain to flow directly into the catch basin from four sides.
 - Incorporate a 3-4" debris dam as part of the new grate support frame.

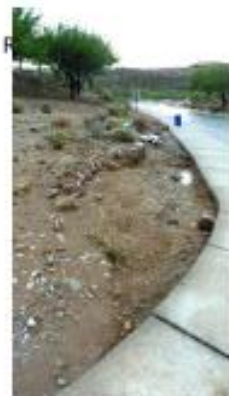
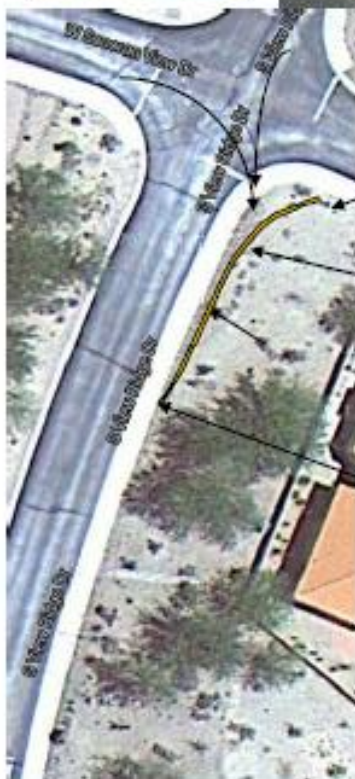
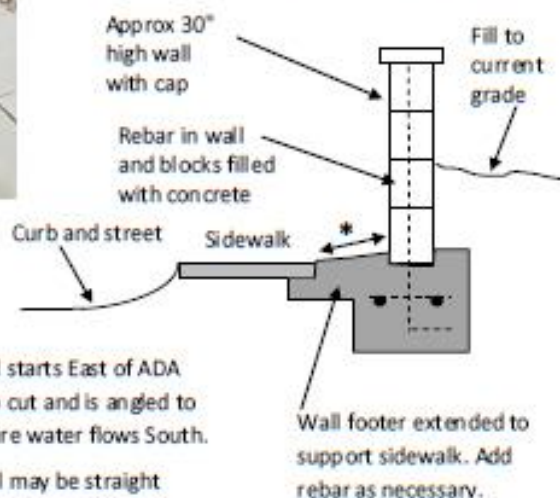
Erosion at Sonoran View and View Ridge -Option 2 Wall

Wall starts East of ADA curb cut and is angled to assure water flows South.

Wall may be straight or curved, but length must be sufficient to route water flow back onto street.

Turn out (if needed) at end of wall to help push water into street.

Cross Section View

* Distance from wall to sidewalk will vary depending on the path of the wall but the area from wall to sidewalk must be continuous sloped concrete.

- Two converging water flows caused course change that took water over sidewalk and into unstable rip-rap area.

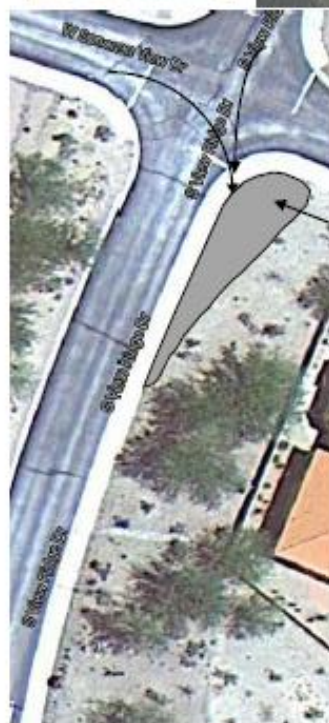
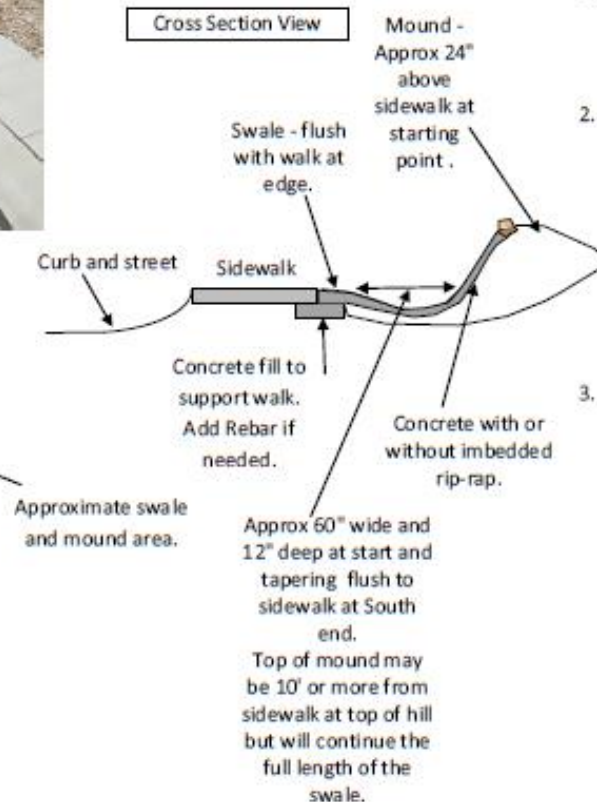
Erosion at Sonoran View and View Ridge

- Two converging water flows caused course change that took water over sidewalk and into unstable rip-rap area.

- Construct swale with mound on East side and line with rip-rap imbedded in concrete.
 - Note slowing down the flow with rip-rap may cause flow to back up.
- OR Construct a mound and smooth concrete swale. (Perhaps with row of rip-rap along the top).
